Quiet Nightclubs.

Philip R Dunbavin, FIOA, PDA Ltd.

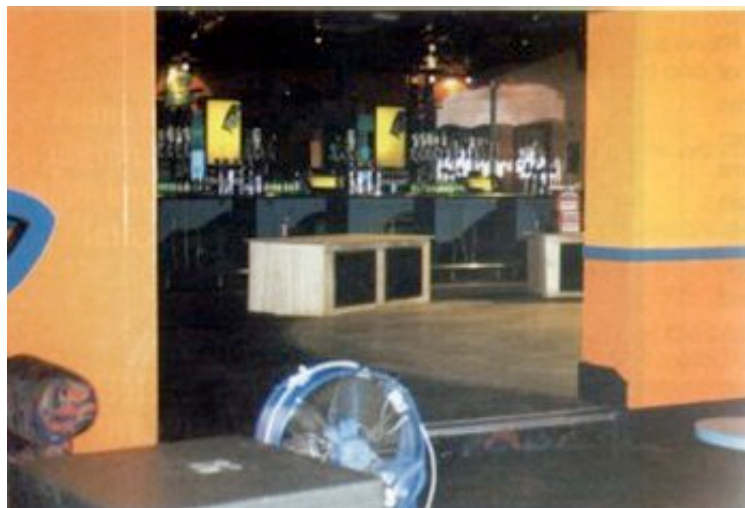
Figure 1.

The venue has some added problems all of which are exacerbated by lack of space. Figure 1 shows that Bar 5 is only two paces from the dance floor. This proximity of bars to the dance floors was common to all five bars. Even worse, the cloakroom for Club 2 was equally close to the dance floor. The concept of a 'quiet area' would be impossible to realise in such a small venue.

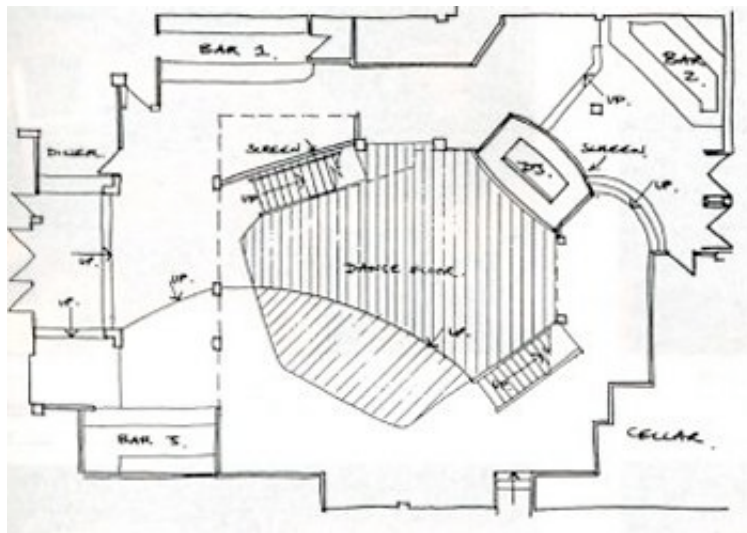
Figure 2. Club 1, Floor plan.

Figure 2 shows the ground floor layout of Club 1 and it must be remembered that there is a mezzanine floor above Bars 1 and 2 on which Bar 4 is located directly above Bar 2.

In Club 1 the same treatments were applied with a few additional measures:- The wall areas which were out of reach of the clientele were finished with a sprayed acoustic absorber. Some wall areas and ceilings under the bars were finished with mineral wool behind galvanised perforated sheet steel. This is an unusual finish but just happened to meet with the approval of the interior designer.

A large glass screen was introduced in front of Bar 1 at the side of the stairs to screen the bar from the dance floor. The DJ console was built as an acoustic screen to provide some screening to Bar 2. Figure 7 shows the DJ console which totally obscures the bar behind. Bar 4 can also be seen in this photograph on the mezzanine.

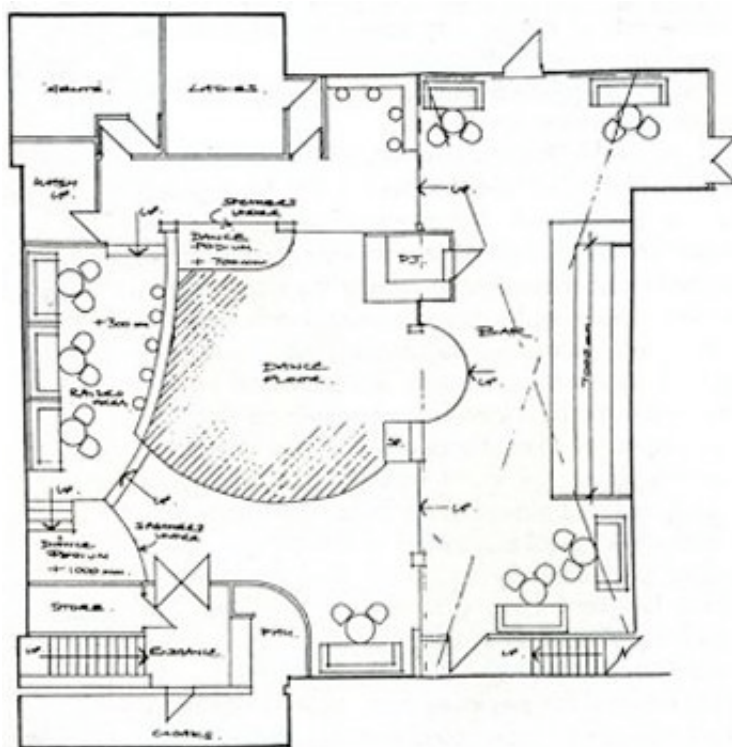
Figure 3. Club 2, Floor plan.

Figure 3 shows the revised layout for Club 2.

In Club 2 several key elements were introduced:- The cloakroom was moved together with the

paydesk to directly next to the entrance and it is separated from the dance floor by a wall. The bar was moved from the position now occupied by the raised seating area to the opposite wall increasing the distance between the bar and the dance floor.

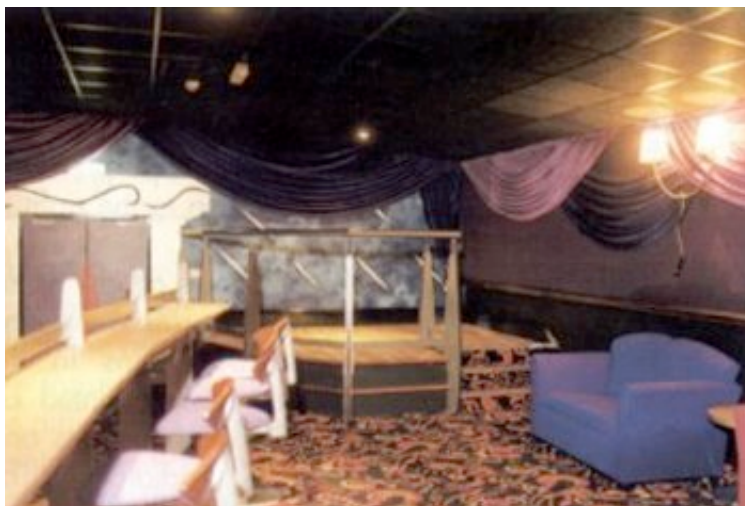
All the loud speakers were orientated to point away from the new bar. The entire ceiling area was faced with acoustically absorbent material. Figure 4 shows the black coloured acoustic ceiling tiles over the raised seating area.

As much of the wall areas as practical were also covered with acoustic absorbent faced with a purple cloth. This can be seen to the right of Figure 4.

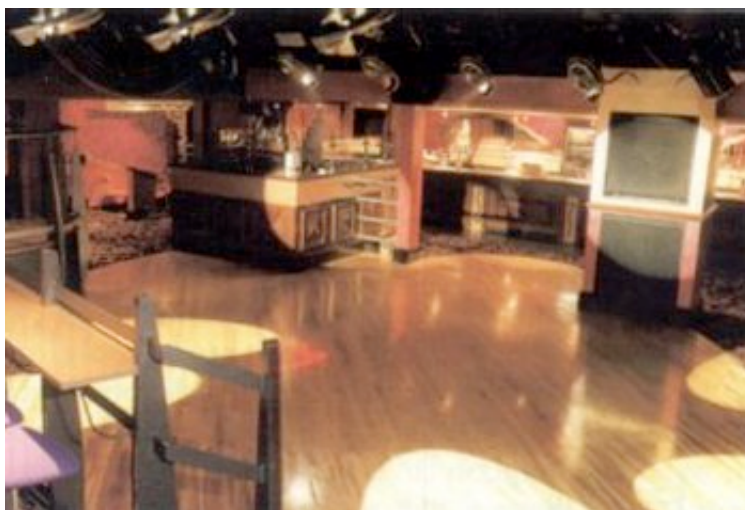
Figure 5.

Figure 5 shows a view of the bar from the raised seating area. The bass bins in the column are mounted on vibration isolation mounts and are direct radiators. The vibration isolation mounts prevent the low frequency energy entering the structure which can produce unpleasant buzzes and rattles in fixtures and fittings.

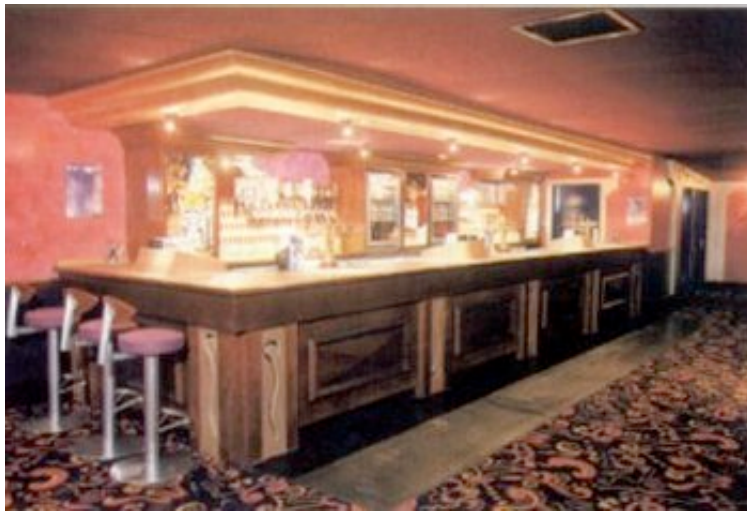
Figure 6.

Figure 6 shows that the absorbent ceiling extends right underneath the bar and the bar opening is kept to the minimum commensurate with operational requirements.

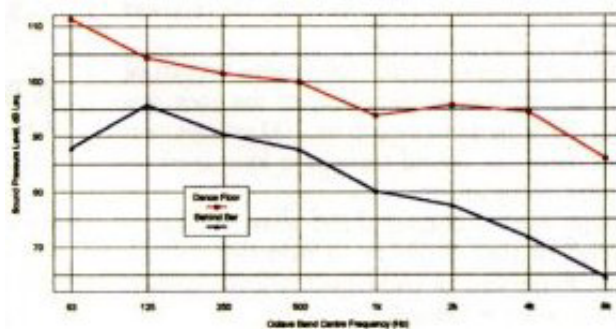
Figure 9. Spectra on the dance floor and behind the bar.

From the clientele point of view the sound system is very good and they do not have to scream at the bar staff in order to get a drink. The level on the dance floor was 103 dB(A) Leq which reduced to 89dB(A) Leq behind Bar 3.

This is shown in octave bands in Figure 9. In physically larger venues the same techniques are even more effective and easier to implement. These basic measures can be designed into new night-clubs and retrofitted to virtually any club undergoing a refurbishment.
