Quiet Nightclubs.

Philip R Dunbavin, FIOA, PDA Ltd.

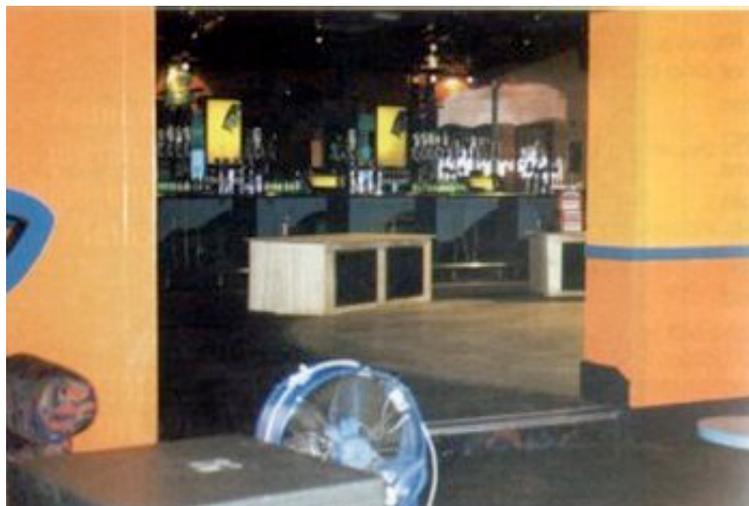
Figure 1.

The venue has some added problems all of which are exacerbated by lack of space. Figure 1 shows that Bar 5 is only two paces from the dance floor. This proximity of bars to the dance floors was common to all five bars. Even worse, the cloakroom for Club 2 was equally close to the dance floor. The concept of a 'quiet area' would be impossible to realise in such a small venue.

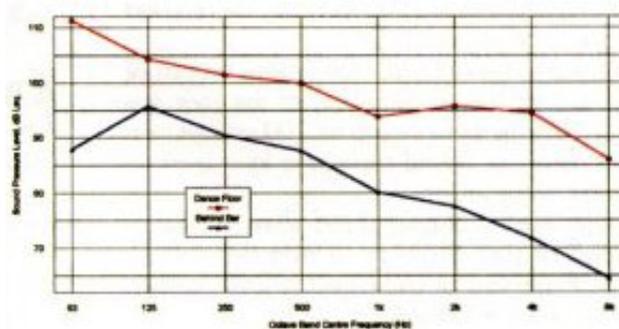
Figure 9. Spectra on the dance floor and behind the bar.

From the clientele point of view the sound system is very good and they do not have to scream at the bar staff in order to get a drink. The level on the dance floor was 103 dB(A) Leq which reduced to 89dB(A) Leq behind Bar 3.

This is shown in octave bands in Figure 9. In physically larger venues the same techniques are even more effective and easier to implement. These basic measures can be designed into new night-clubs and retrofitted to virtually any club undergoing a refurbishment.
