Leeds Metropolitan University - Design and Build of new Acoustic Laboratory Suite

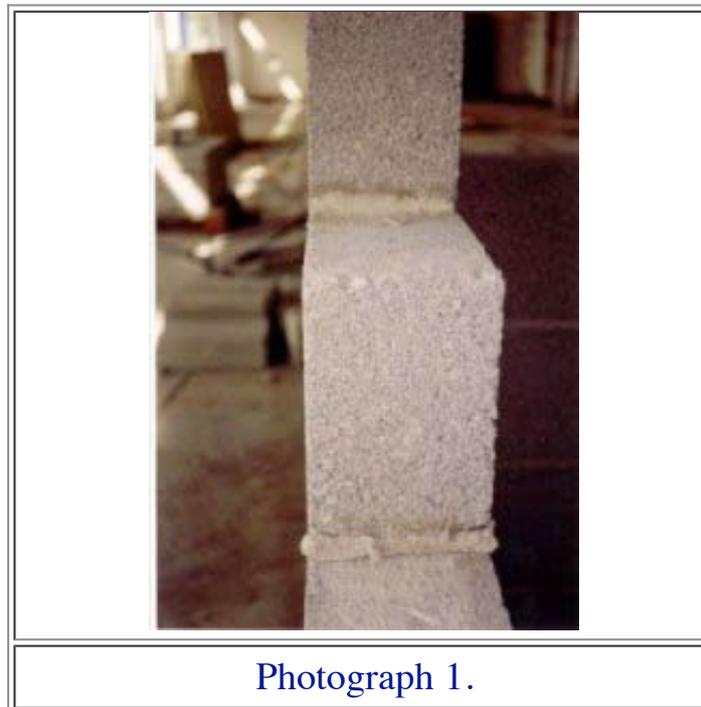
The fundamental construction for all of the chambers was a solid blockwork wall. Good quality blockwork is vital to the acoustic performance of any normal wall, but is absolutely paramount in the construction of any chamber within an acoustic laboratory. Correct block selection is the key, with all blocks being complete with no cracking or pitting. Mortaring must be to an almost fair faced standard with joints being completely filled. Photograph 1.0 shows a fully mortared joint.

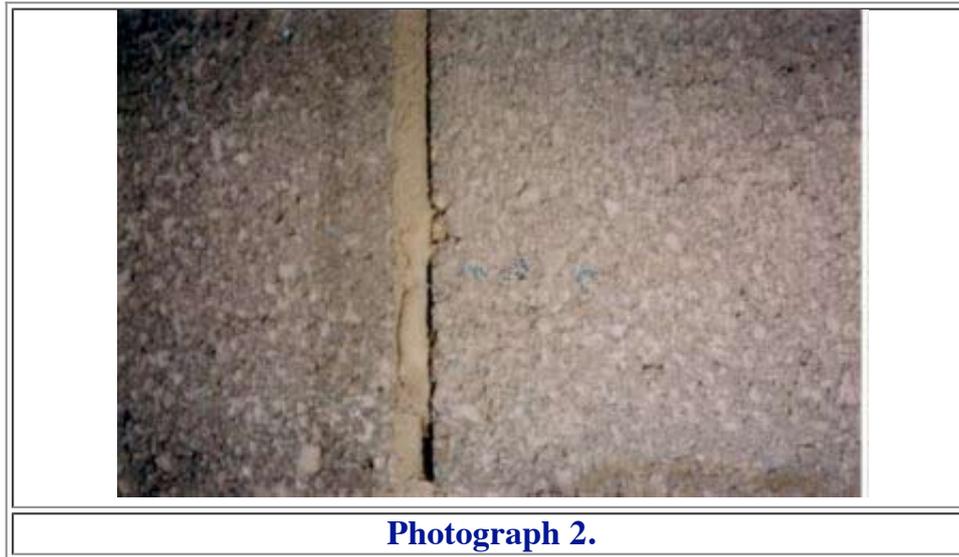
However, problems can still occur even with correctly filled joints. Photograph 2.0 shows a joint where the mortar has been subject to shrinkage, through no fault of poor workmanship. Although this doesn't appear to be a major problem, photograph 3.0 shows that the gap extends for over 80mm, almost the entire depth of the block!

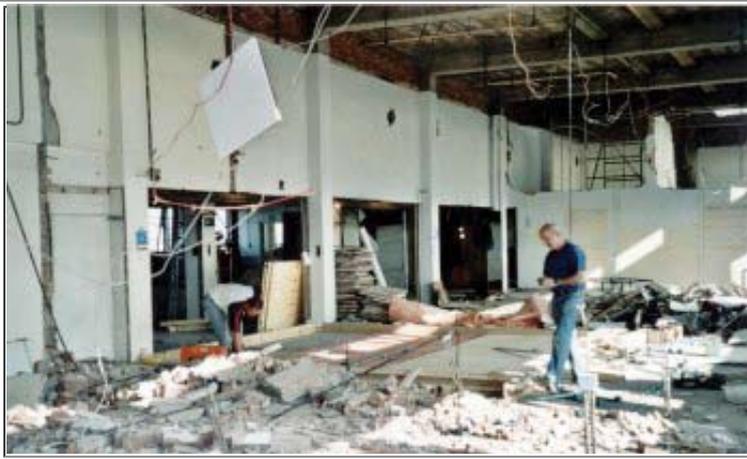
Photograph 4.

Photograph 4.0 shows the initial construction of the floating floor for the small reverberation chamber. This photograph highlights the difficulties associated with ensuring that debris does not accumulate and bridge the isolation system. However, photograph 5.0 shows that the floor installation was clean. This photograph also underlines the importance of site inspections at critical phases of the construction. In this case, if the inspection had been performed a day later, the floor would have been complete and ready for the pour, as shown in photograph 6.0. In which case, the only proof that would exist that the installation was clean, would be the word of the installers!

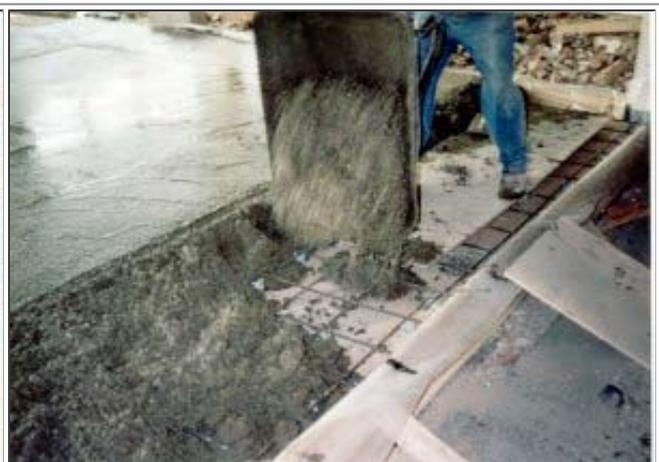
Photograph 7.

Photograph 7.0 shows the pouring of the concrete slab. The concrete could not be pumped up to the ninth floor, and so the only alternative was to use barrows. Unfortunately, the lift could only accommodate two barrows at a time and therefore the pour took approximately five hours! A point worthy of note on this photograph, is the use of a protective boarding placed on the reinforcing steel work, to ensure that the spacers were not damaged as a result of a direct point load.

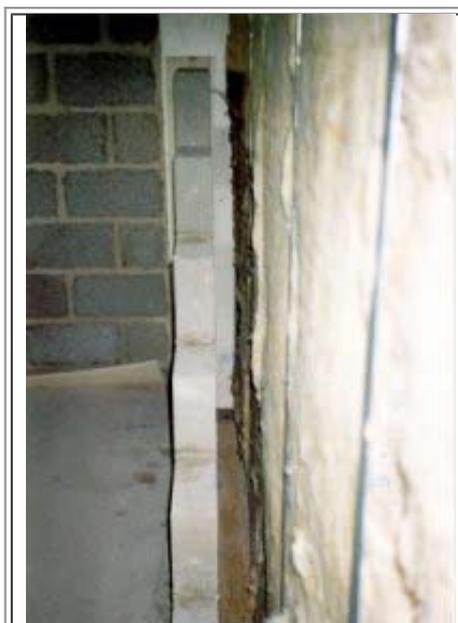
Photograph 8.

Photograph 8.0 shows blockwork built off the floating slab, with a good clean cavity present thereby ensuring complete isolation.

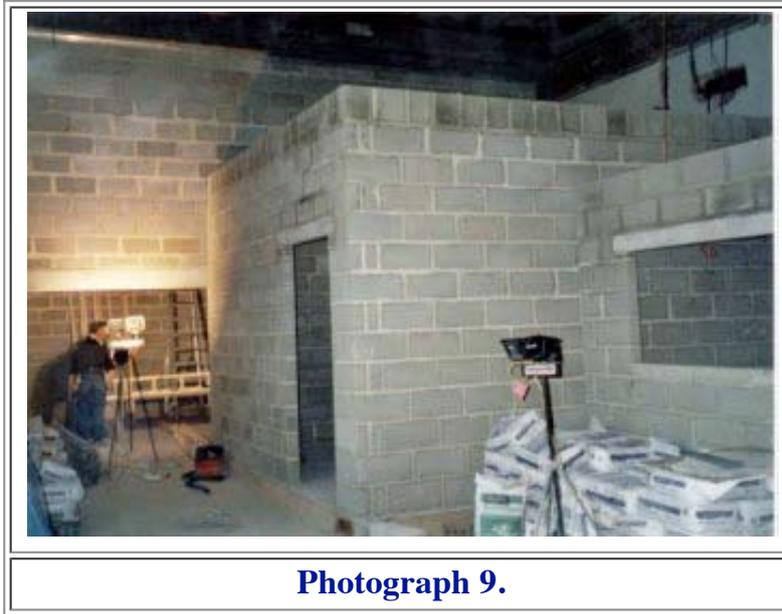
Photograph 9.

Photograph 9.0 shows the ongoing construction of the small and large reverberation chambers approaching completion. Note the good quality of blockwork throughout.

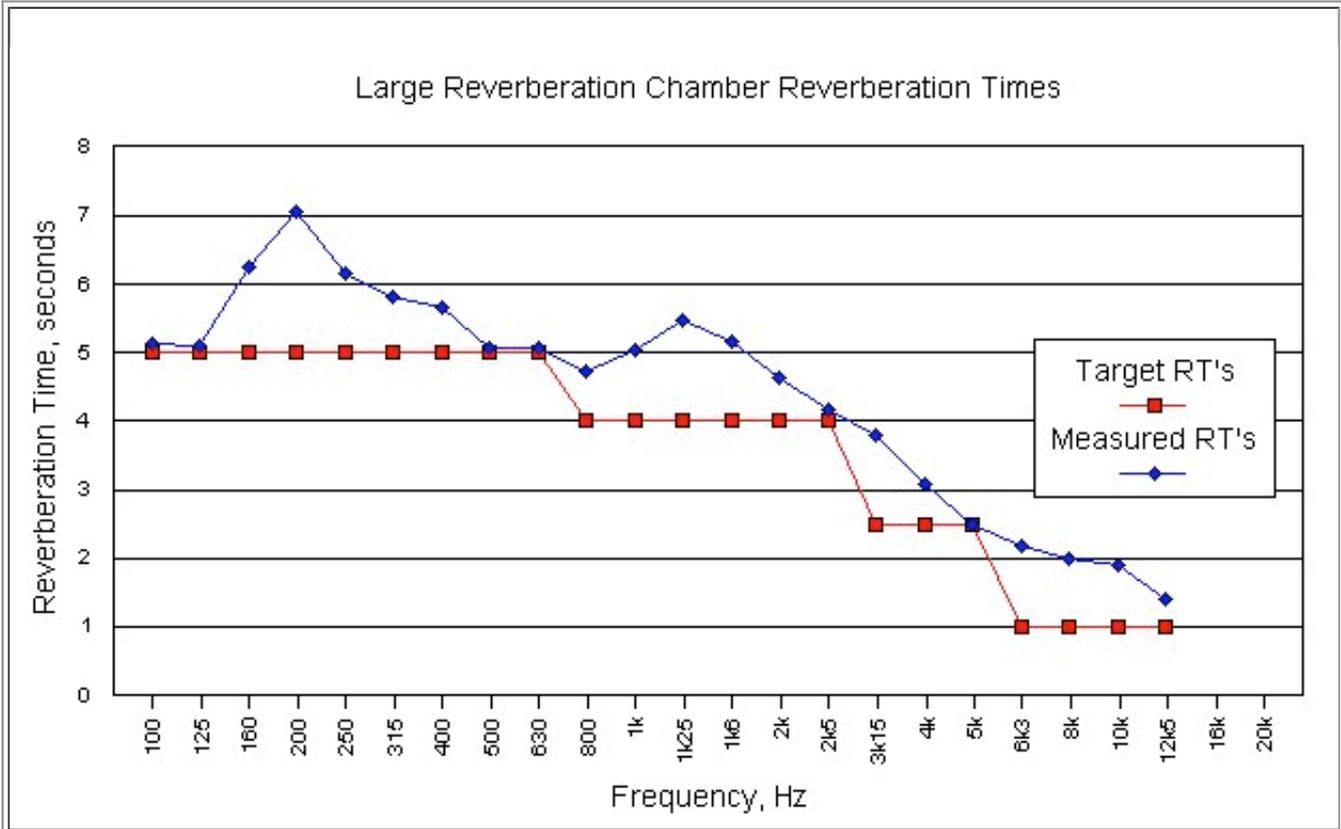
Graph 1.

Graph 1.0 shows the RT of the large chamber and it can be seen that the performance criteria has been met or exceeded in all third octave bands. However, slightly longer times were expected at the lower frequencies and it is likely that the reason for the RT drop off is a result of the ceiling acting as an absorber despite the sand pugging.

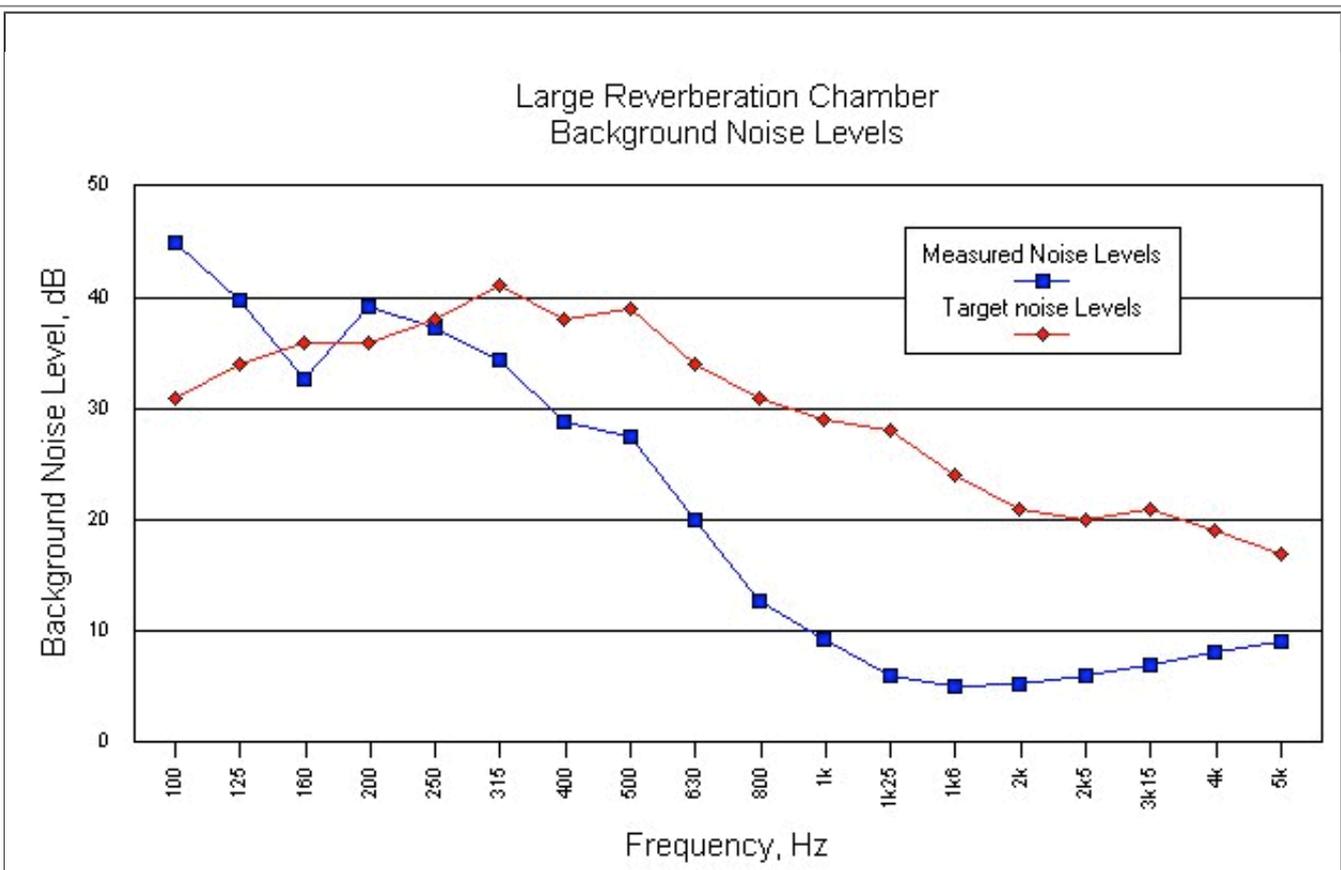
Graph 2.

Graph 2.0 shows the ingress of low frequency noise as predicted, from structural vibration from operation of the lifts. However, the level of noise is not excessive and does not restrict the capabilities of the laboratory.

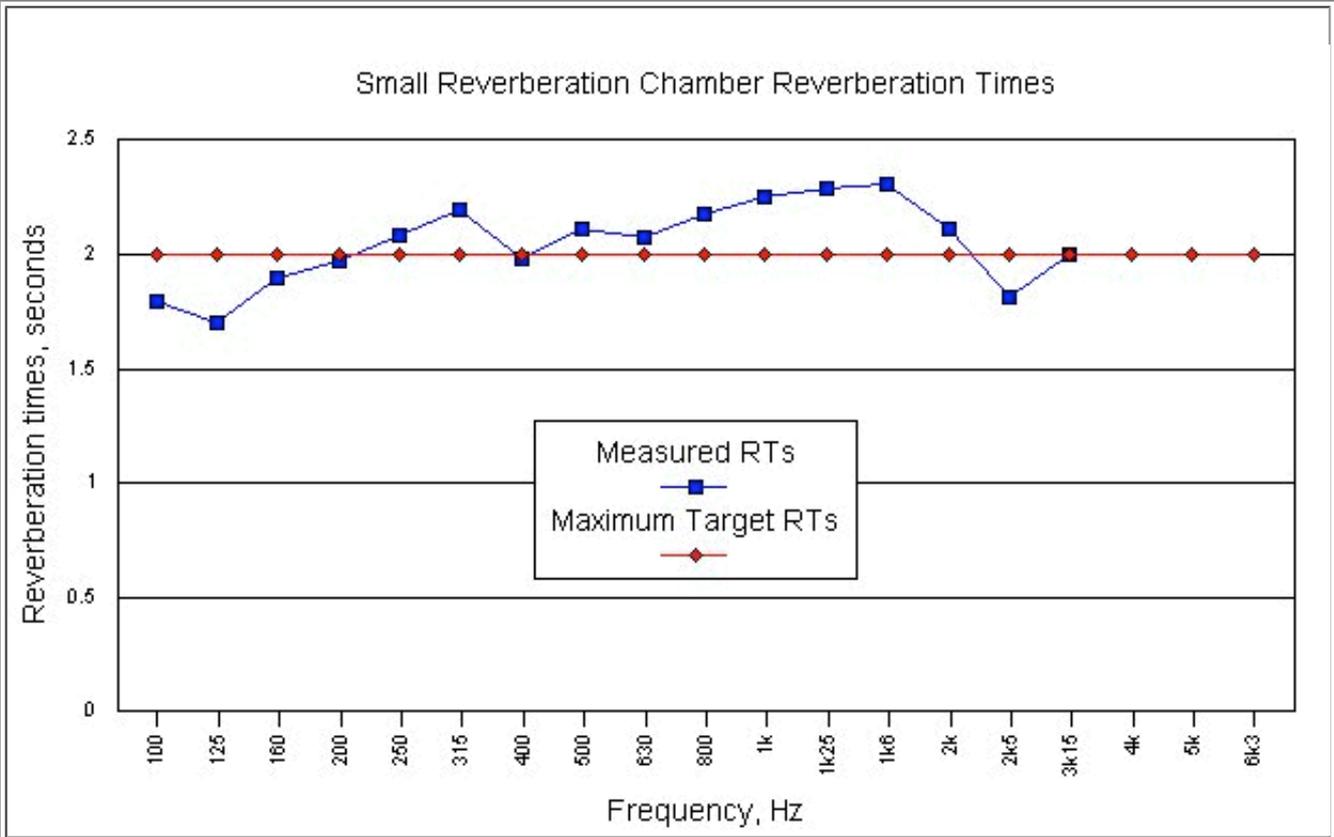
Graph 3.

Graph 3.0 shows the RTs for the small chamber. It can be seen that the maximum target value is exceeded in the majority of frequency bands. This was intended, with the view that additional absorption could be introduced in order to "fine-tune" the chamber.

In practice, this additional absorption is in the shape of an additional student, since students work in pairs within the chamber. The background noise levels within the chamber are shown in graph 4.0. On

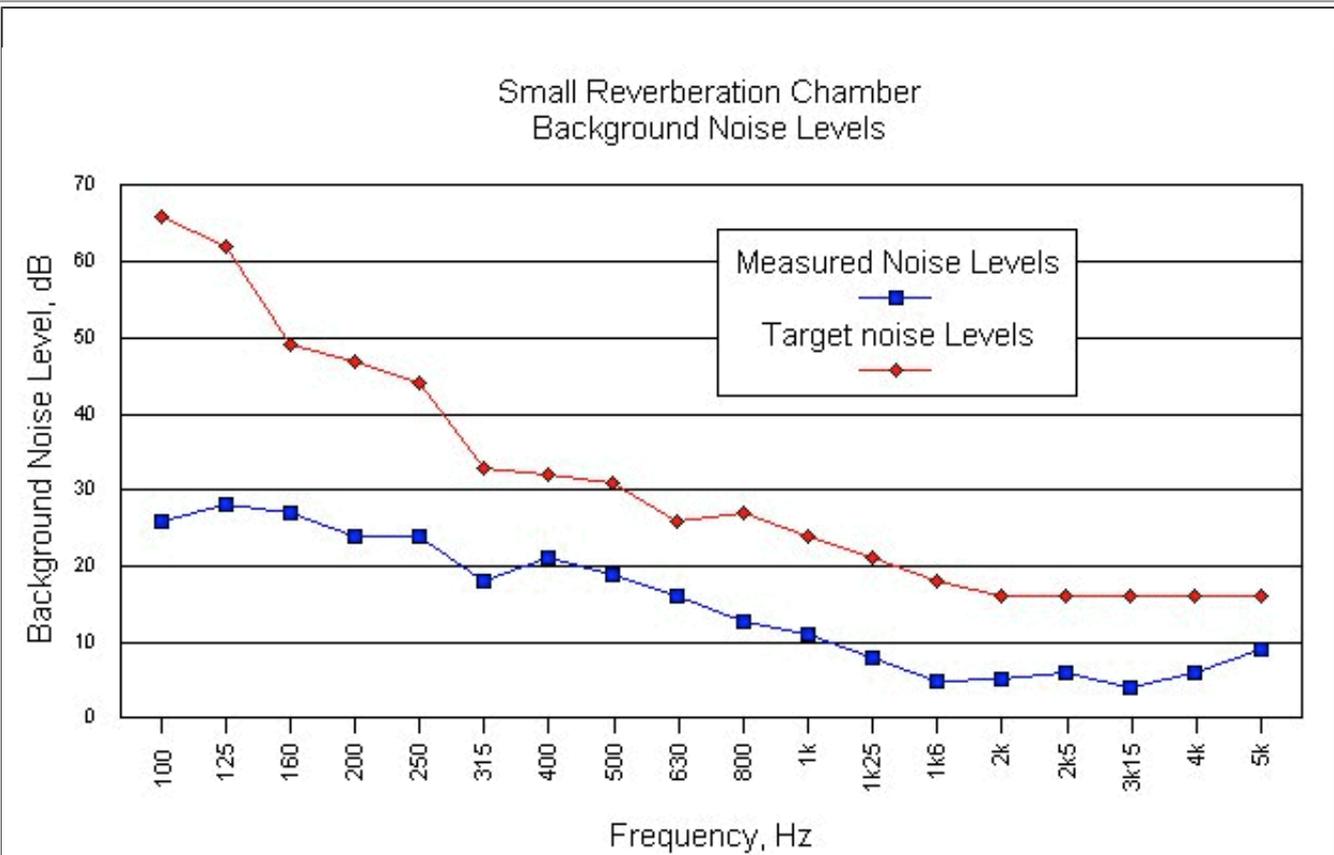
Graph 4.

comparison with graph 2.0 the isolation effect of the floating floor is apparent, and demonstrates that the floor is performing correctly with no breaches in the isolation existing.

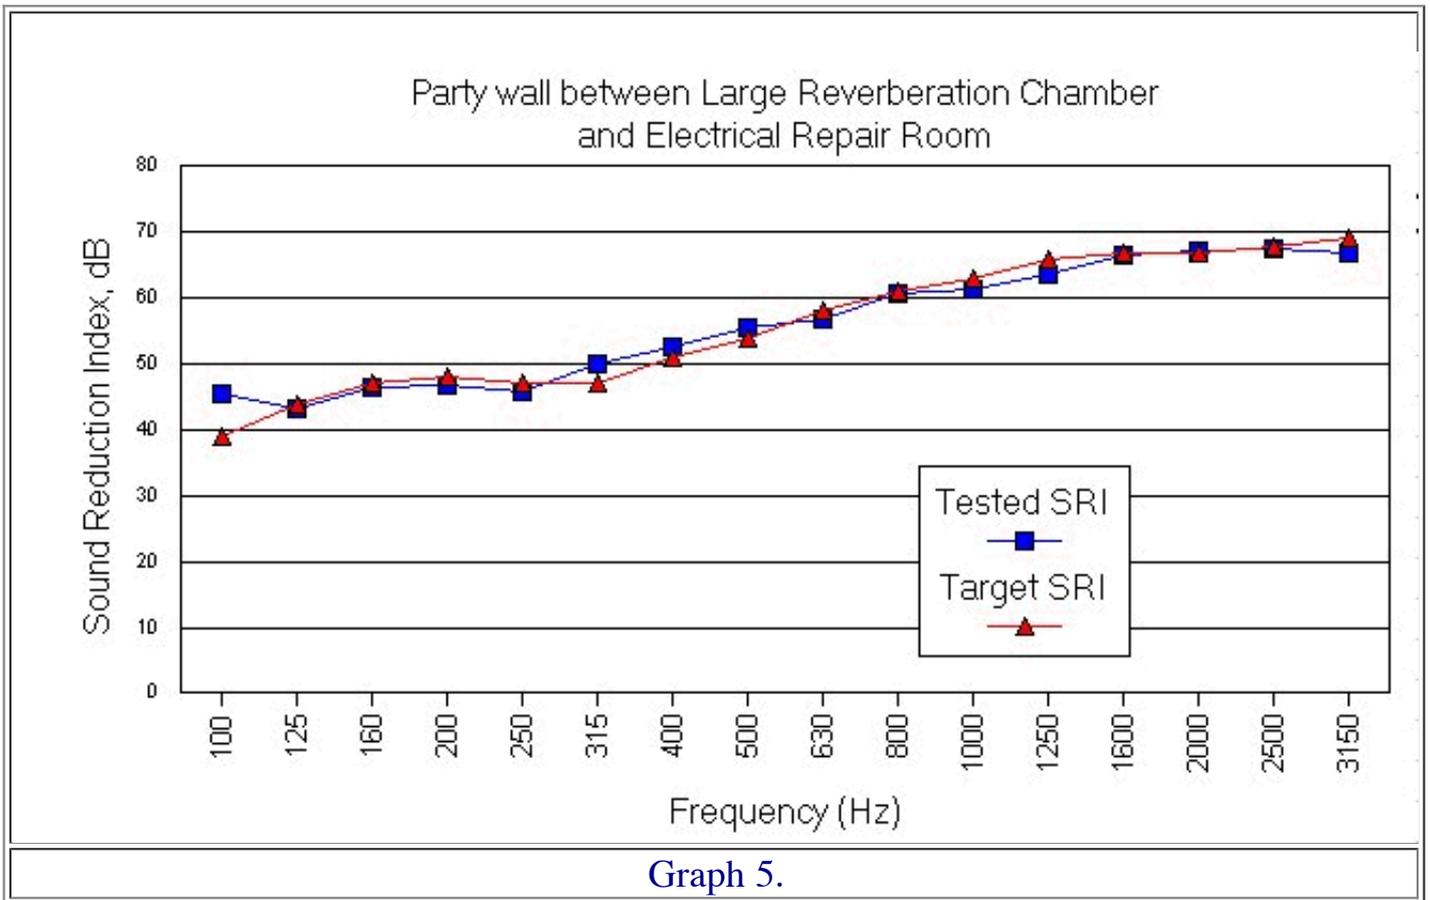
Graph 5.0 details the Sound Reduction Index (SRI) of one of the walls of the large chamber. This wall was tested for practical reasons since it was the only non-composite façade.

The results for this wall performance show almost an exact match between the tested and target values and are testament to the high quality of workmanship that existed throughout the project.
